Manhole Inspection Summary

Manhole # S43W__015MH

Insp Date: **3/4/08 9:25 AM**

Location Address: **1425 decatur st.**

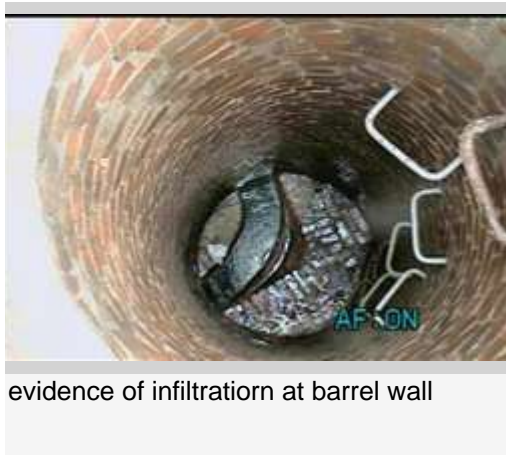
Defect 1

Infiltration: ☐ None ☐ Joint ☐ Cracks ☐ Mortar ☐ Roots ☒ **Wall**

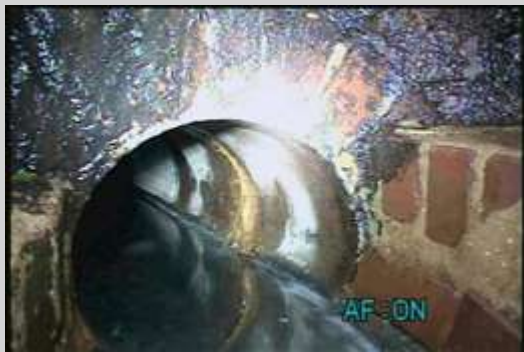
12 O'Clock Outflow

12 in. Circular Gravity Sewer
Pipe Out @ 12 O'Clock

Pipe Material: **Clay** ☐ Pipe Lined

Invert Depth: **12.30** (ft.) Flow Characteristics: **Slow**

Infiltration: **None** Pipe Seal Cond: **Unknown**

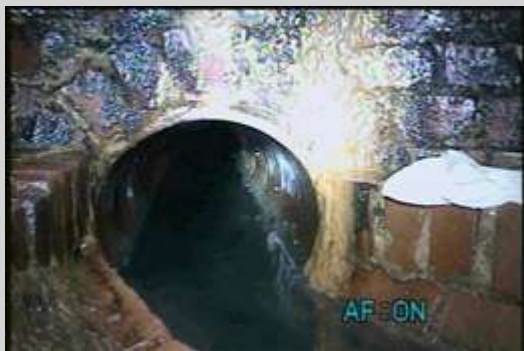
8 O'Clock Inflow

12 in. Circular Gravity Sewer
Pipe In @ 8 O'Clock

Pipe Material: **Clay** ☐ Pipe Lined

Invert Depth: **12.20** (ft.) Flow Characteristics: **Slow**

Infiltration: **None** Pipe Seal Cond: **Unknown**
